***A CASE STUDY OF THE COST AND CAUSES  
OF THE TONGAAT MALL ACCIDENT IN  
DURBAN***

**LEONARDA VAN EEDEN**

**SUBMITTED IN FULFILMENT OF THE REQUIREMENTS FOR THE DEGREE  
MAGISTER TECHNOLOGIAE IN CONSTRUCTION MANAGEMENT IN THE  
FACULTY OF ENGINEERING, THE BUILT ENVIRONMENT AND  
INFORMATION TECHNOLOGY, AT THE NELSON MANDELA METROPOLITAN  
UNIVERSITY**

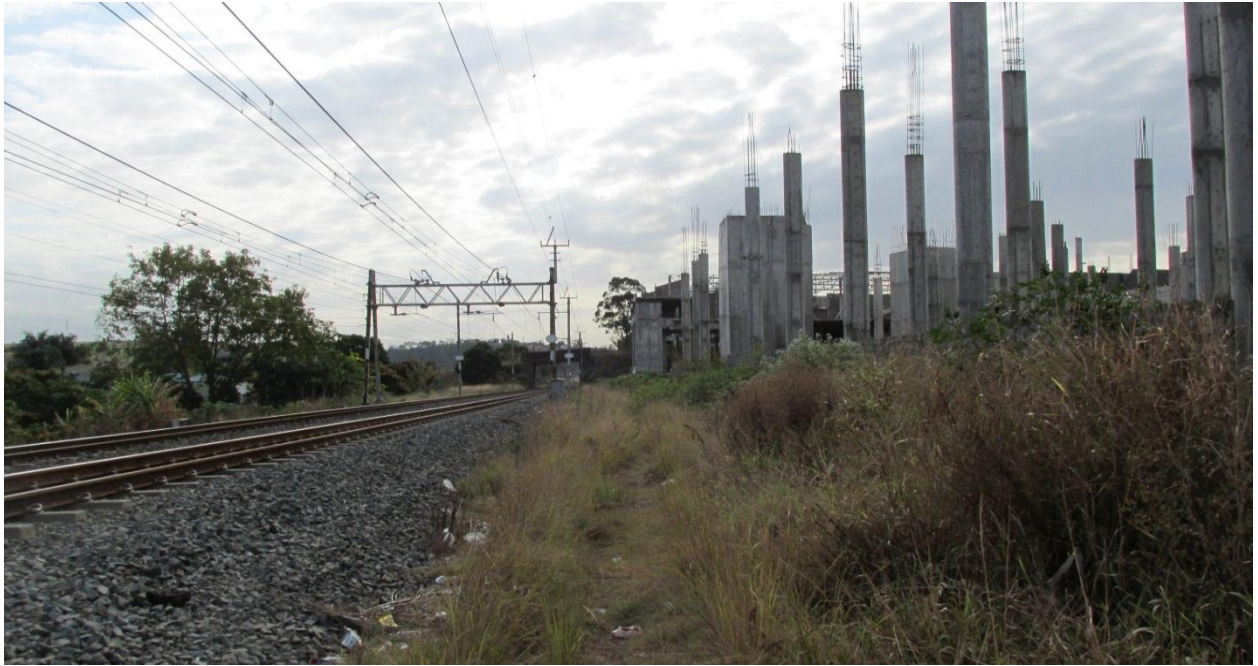
transgressions by the developer were noted during analyses of the documentation. Figure 4.3 indicates the Tongaat mall boundary on the west side. This photo clearly indicates the close proximity of the boundary wall to the railway line. Figure 4.4 similarly indicates the close proximity of the project to the railway line for which approval had to be granted by Transnet. This was, however, not obtained before the collapse according to the analysed document.

Figure 4.3: Tongaat mall boundary on the west side indicating the railway line (Source: van Eeden, 2015)

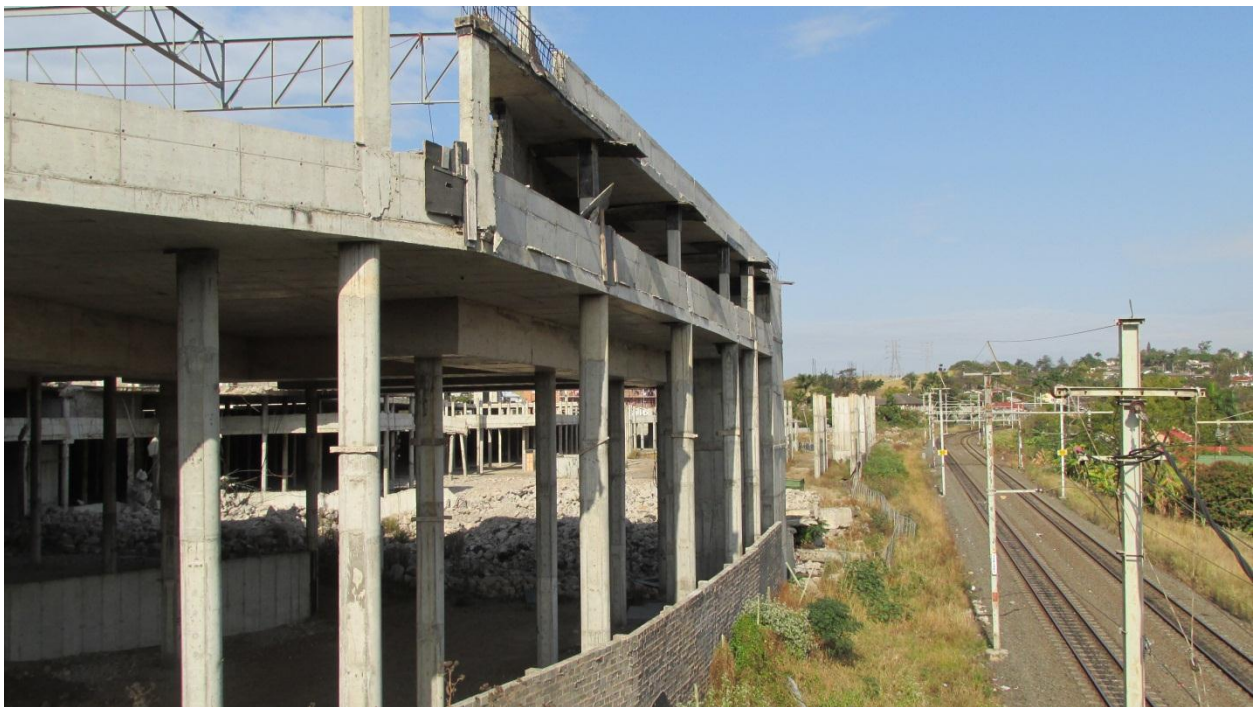
Figure 4.4: Tongaat mall boundary on the west side indicating the railway line (Source: van Eeden, 2015)

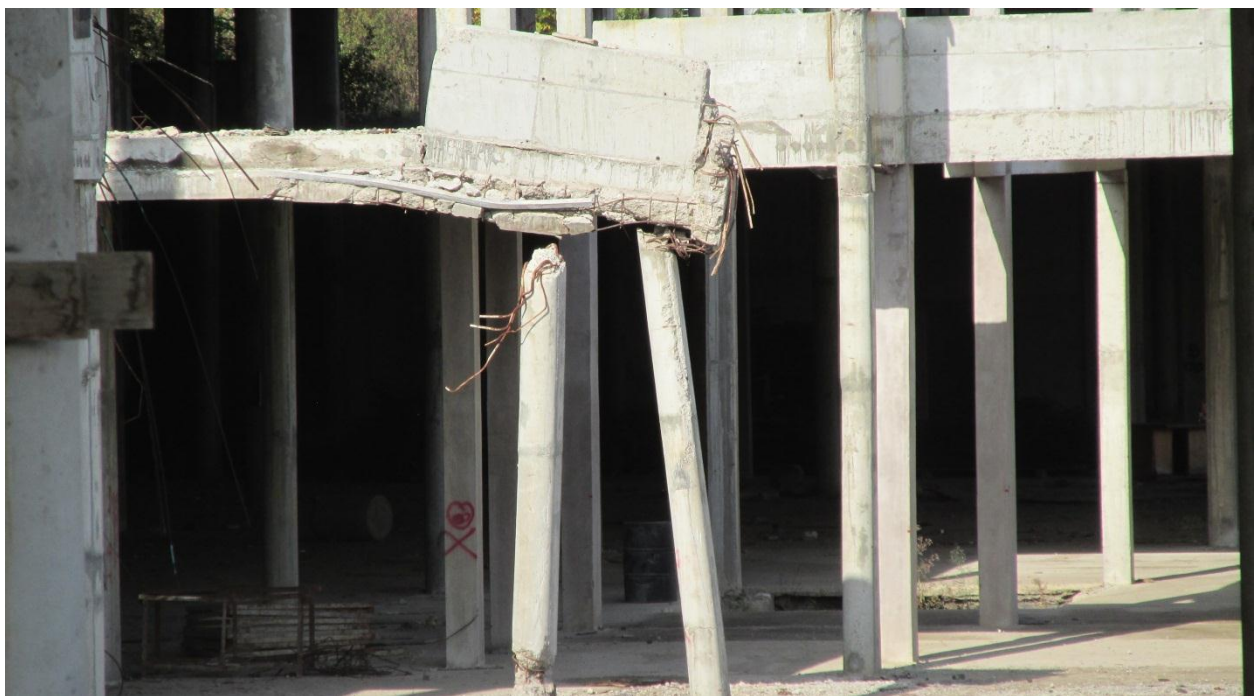
Figure 4.6: Collapsed slab and dismembered columns (Source: Van Eeden, 2015)

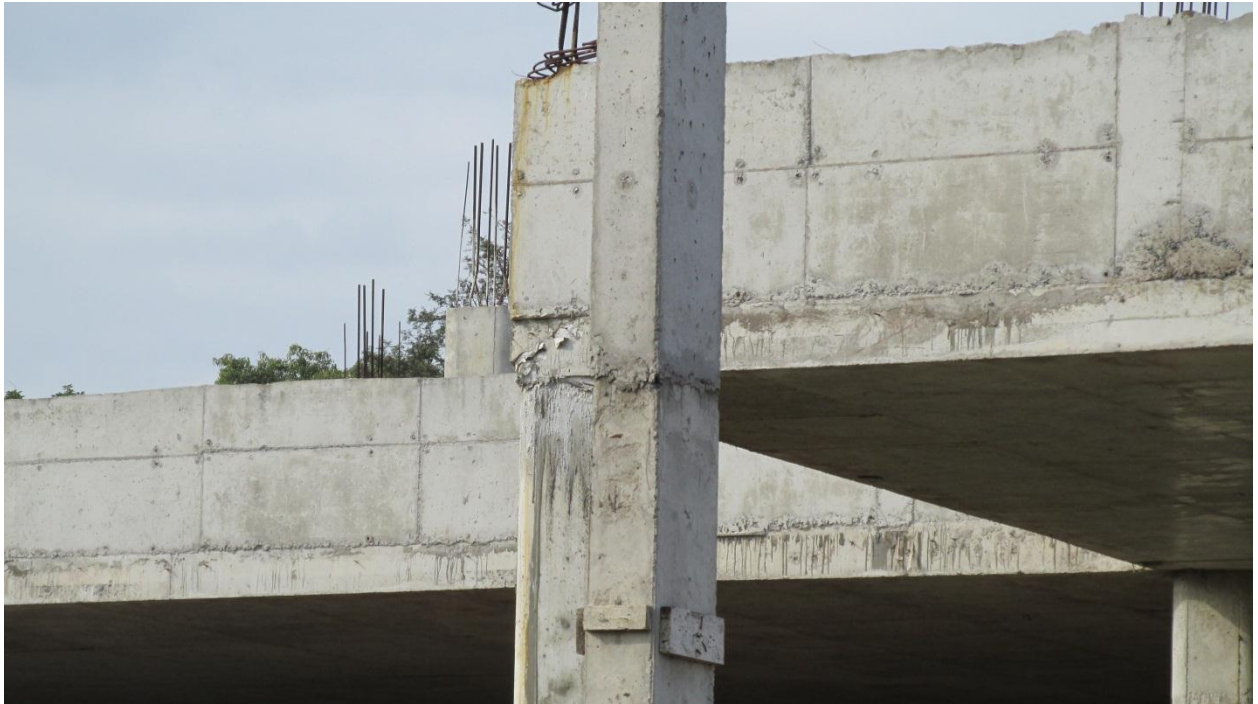
Figure 4.7: Shoddy construction work in terms of column construction that was notable throughout the site (Source: Van Eeden, 2015)

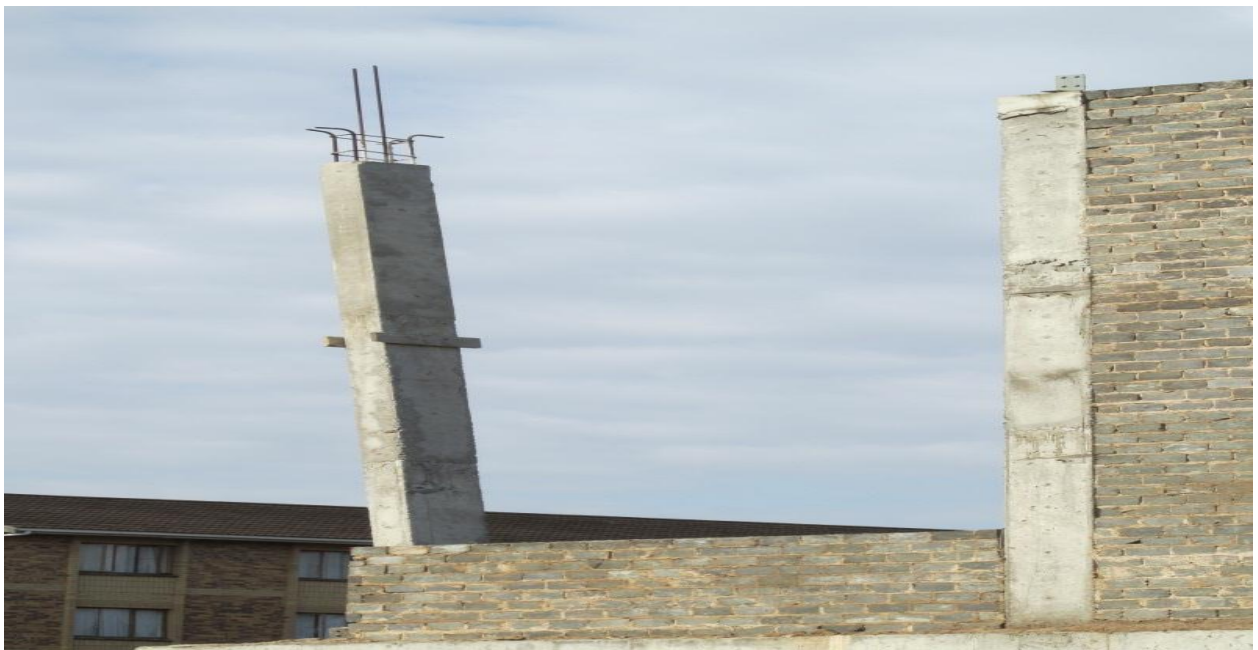
Figure 4.8: Deflection of columns that was notable throughout the site (Source: Van Eeden, 2015)

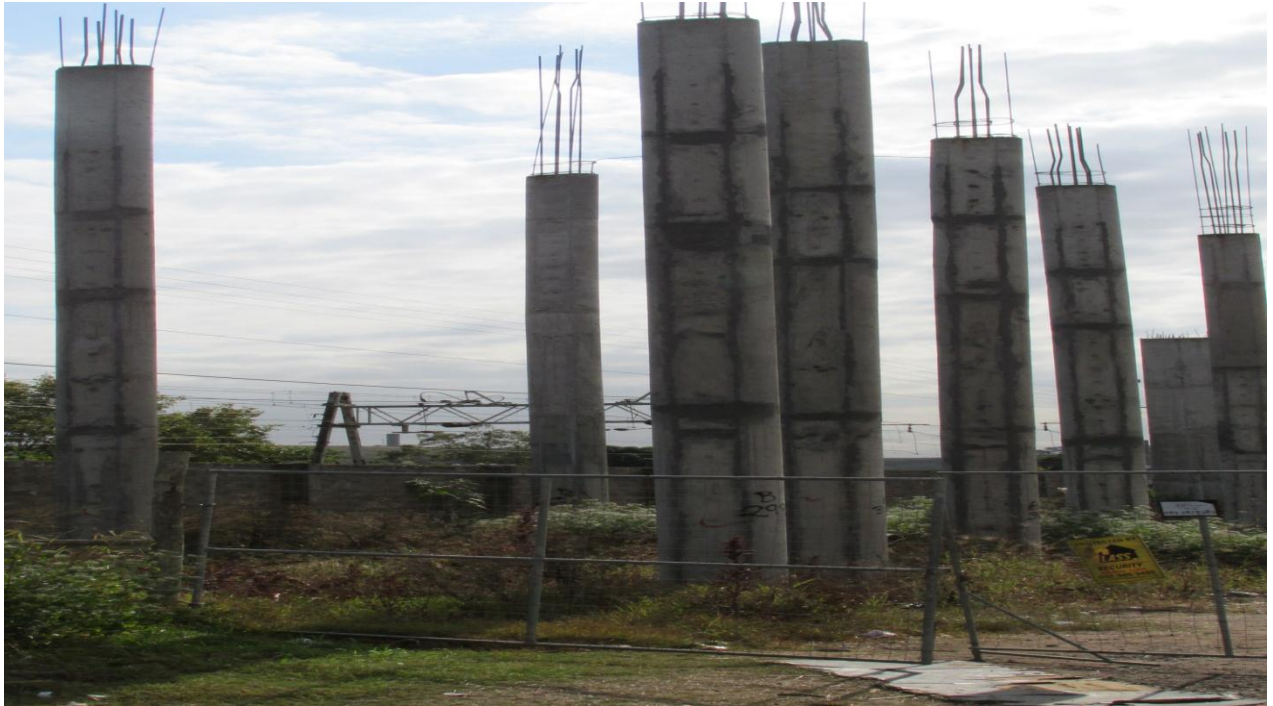
Figure 4.9: Columns that were notably cockeyed throughout the site (Source: Van Eeden, 2015)

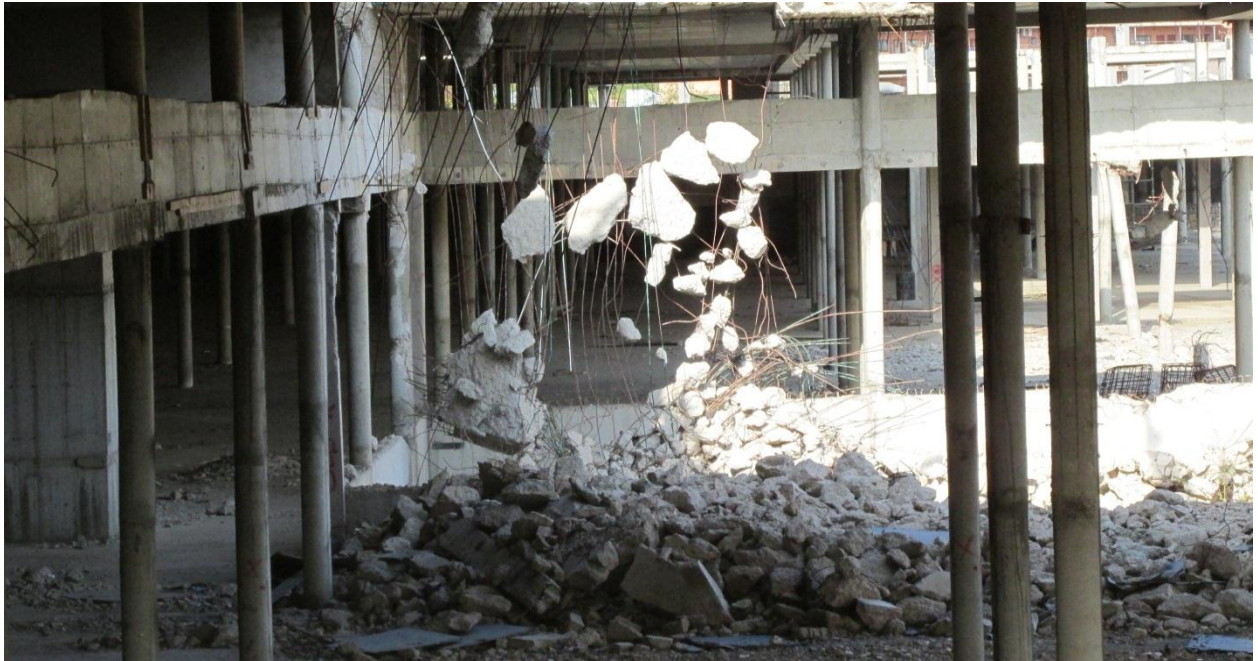
Figure 4.11: Extent of the Tongaat mall collapse – slab view (Source: Van Eeden, 2015)

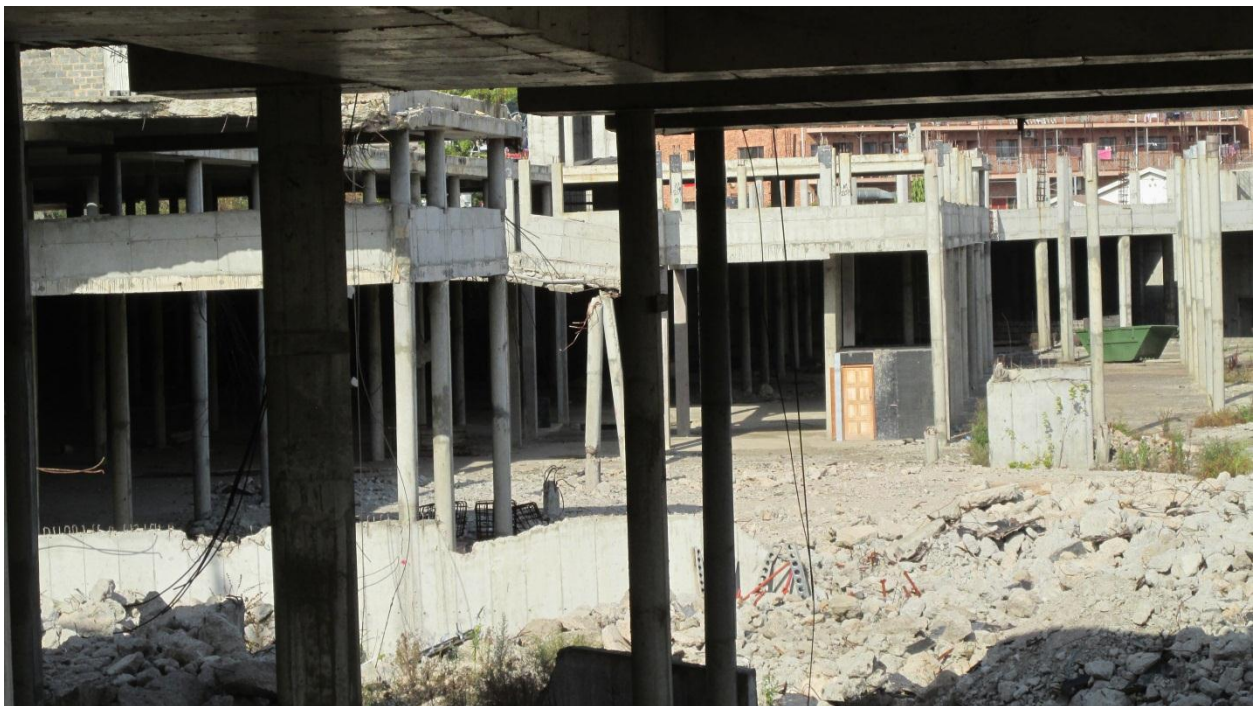
Figure 4.12: Extent of the Tongaat mall collapse – centre view (Source: Van Eeden, 2015)

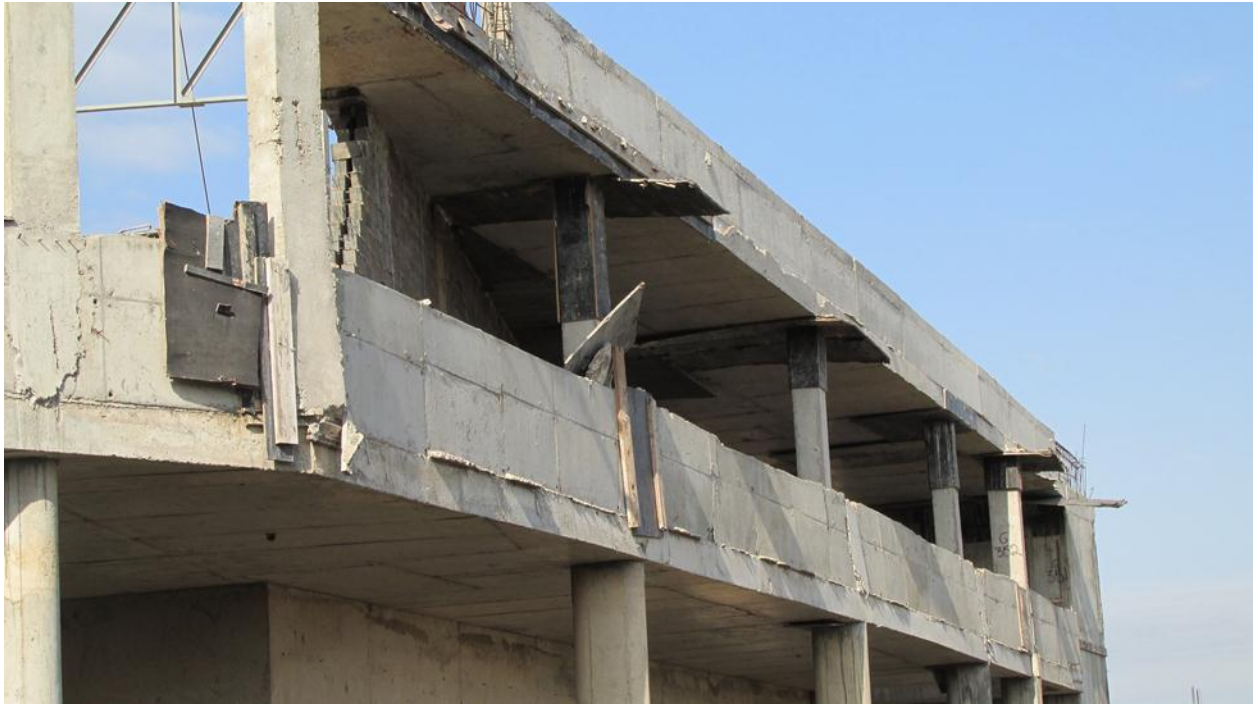
Figure 4.13: Example of poor construction found in the Tongaat mall (Source: Van Eeden, 2015)

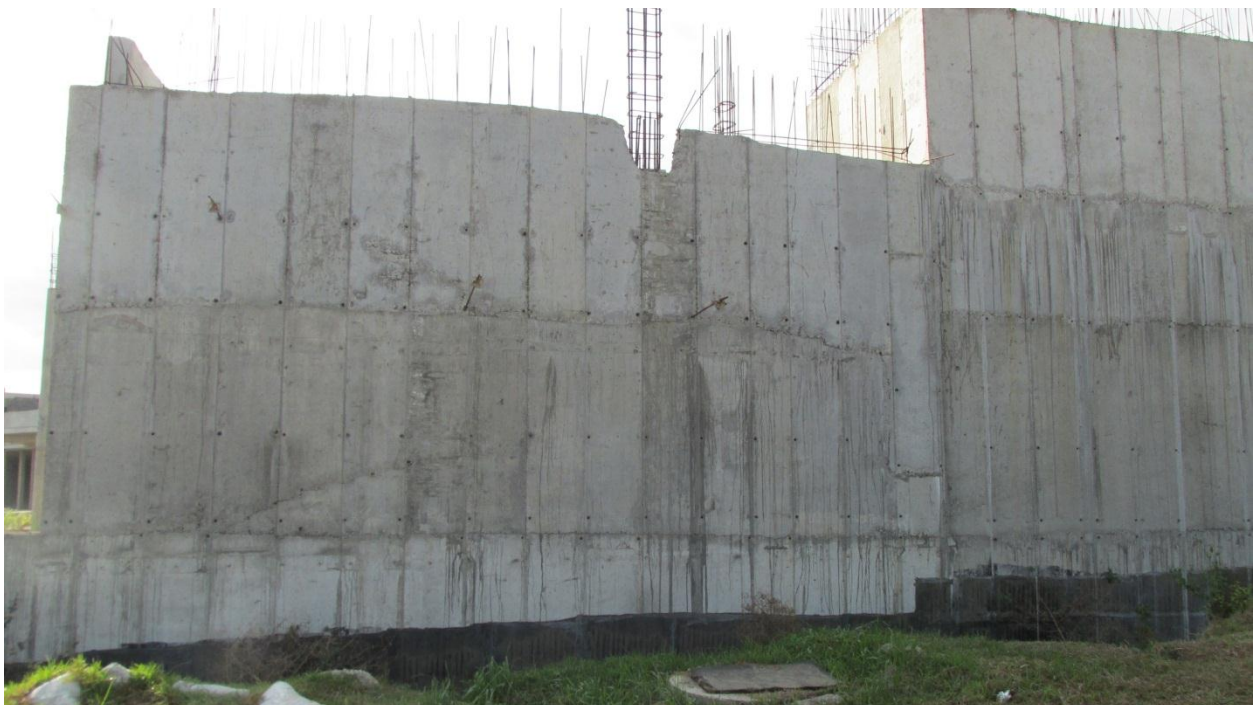
Figure 4.14: Example of poor concrete work evident in Tongaat mall (Source: Van Eeden, 2015)

These traits are notable and correspond with the literature, as indicated in Figure 4.15. The poor concrete strength in the portion that collapsed is noteworthy. The GF indicated that no tests were carried out on the columns. It is also significant that the weakest concrete came from concrete mixed by the GC on site.
