***A CASE STUDY OF THE COST AND CAUSES  
OF THE TONGAAT MALL ACCIDENT IN  
DURBAN***

**LEONARDA VAN EEDEN**

**SUBMITTED IN FULFILMENT OF THE REQUIREMENTS FOR THE DEGREE  
MAGISTER TECHNOLOGIAE IN CONSTRUCTION MANAGEMENT IN THE  
FACULTY OF ENGINEERING, THE BUILT ENVIRONMENT AND  
INFORMATION TECHNOLOGY, AT THE NELSON MANDELA METROPOLITAN  
UNIVERSITY**

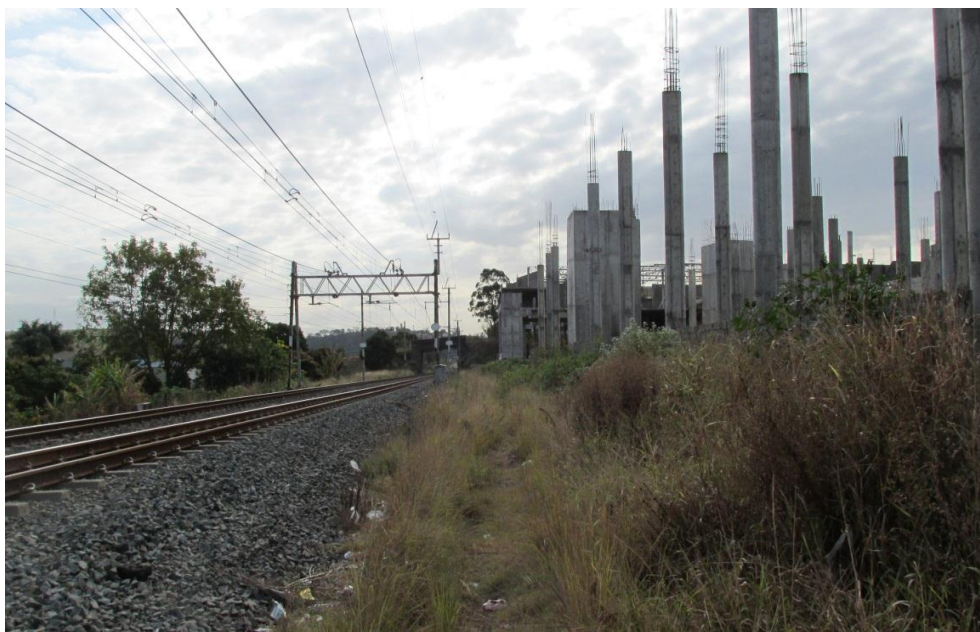
shopping mall was situated on the corner of Gopallal Hurbans Road and Ganie Street, north-east (Figure 3.4) and within 10 metres of the railway line on the west side (Figure 3.5 and Figure 3.6).

Figure 3.5: Mall boundary on the west side indicating the railway line (Source: Van Eeden, 2015)

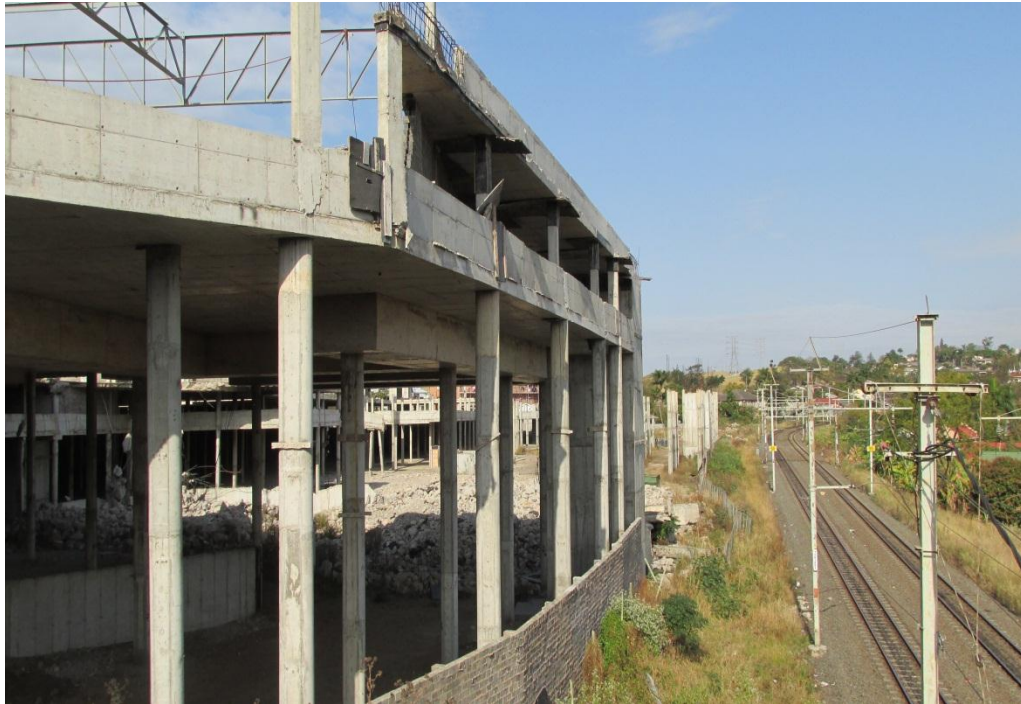
Figure 3.6: Mall boundary on the west side indicting the railway line (Source: Van Eeden, 2015)

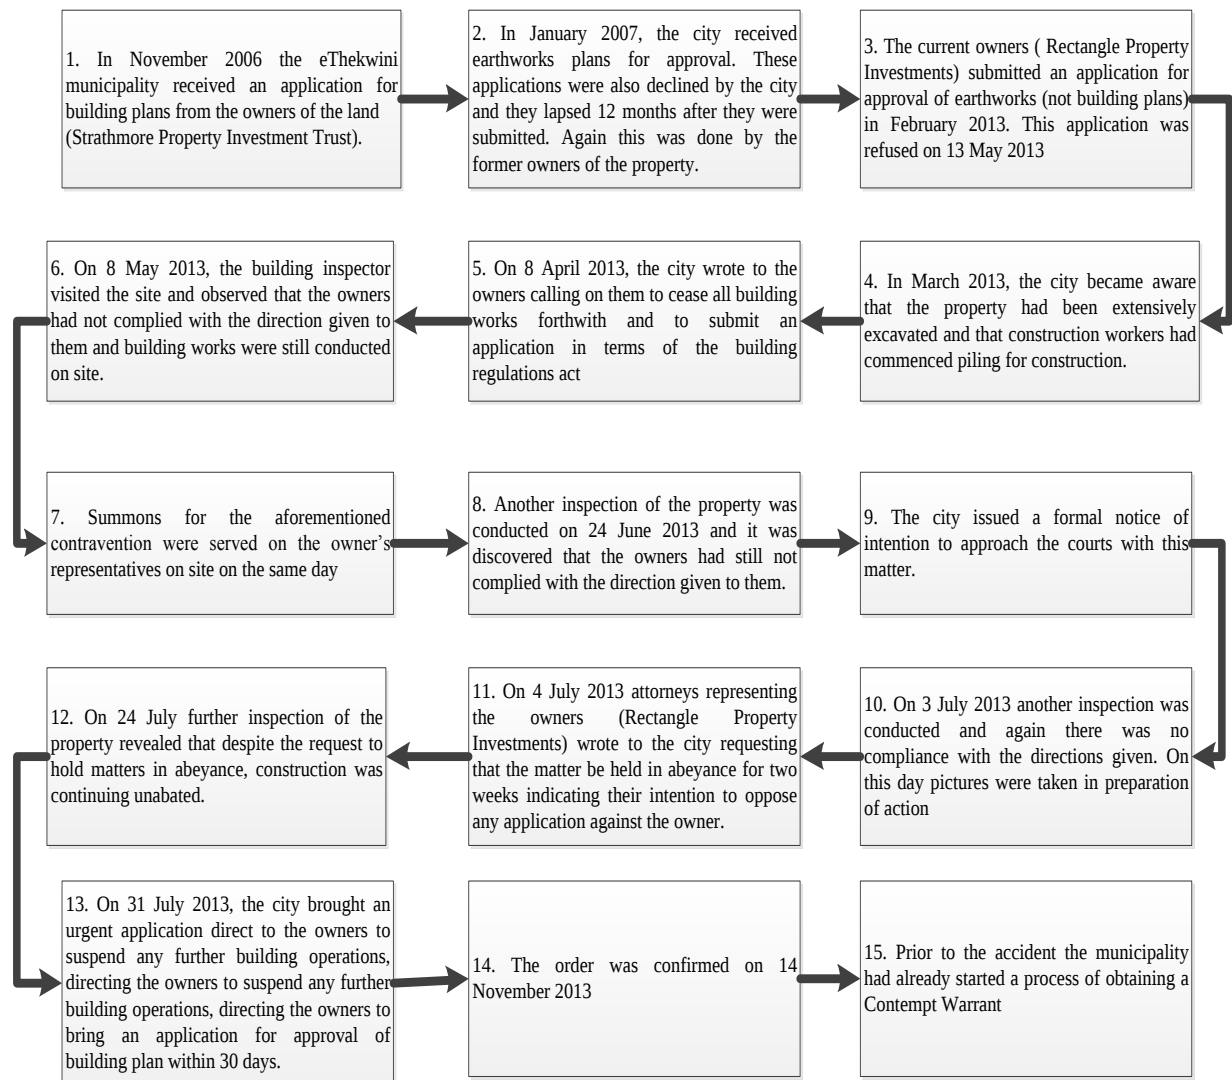
Figure 4.1: Timeline of the events as they transpired at the Tongaat mall project

The information above indicates that despite the promulgation and implications of the construction regulations it is notable that the client, general contractor, general foreman and H&S agent lacked the sufficient knowledge stated in the regulations (Republic of South Africa, 2003; 2014).

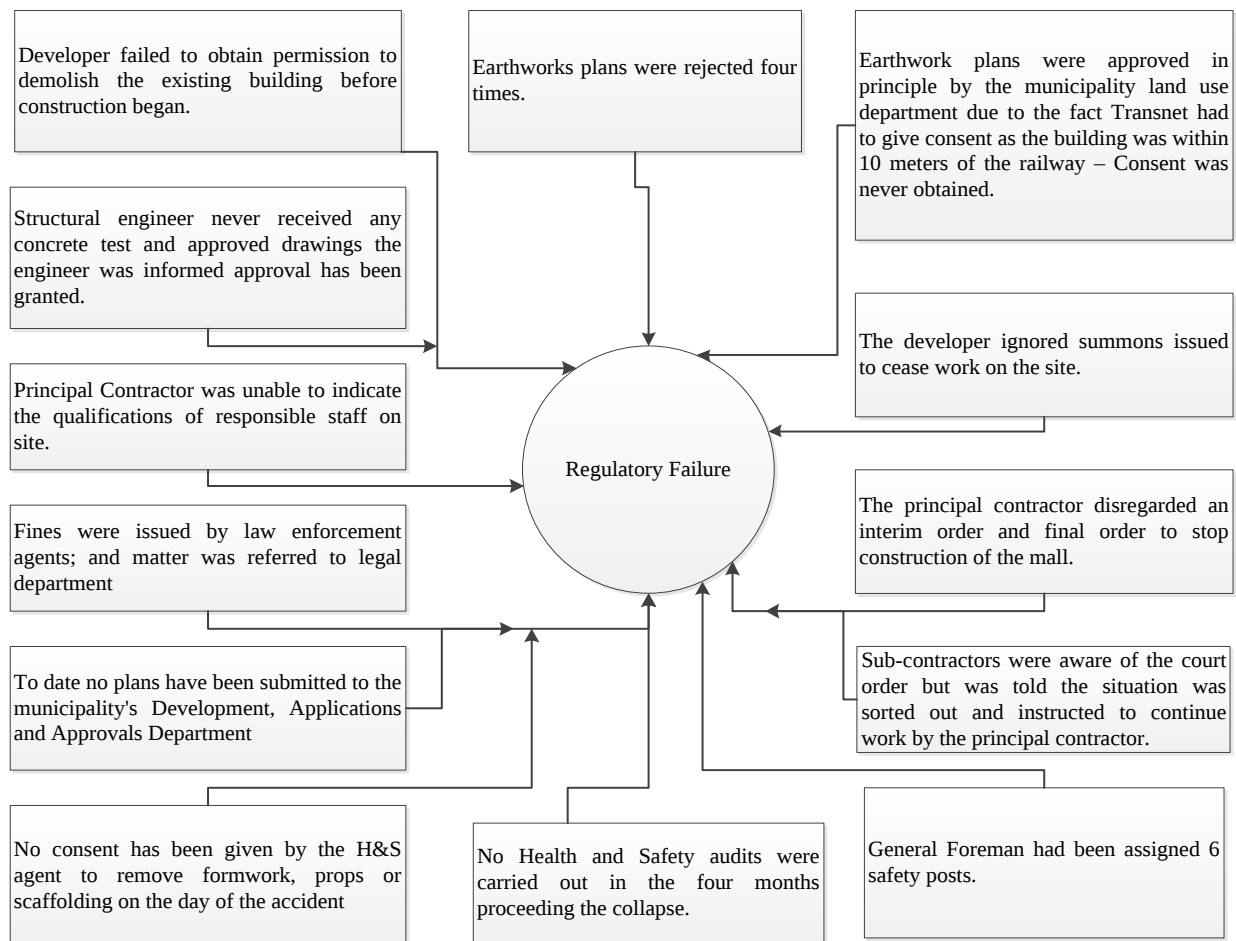
Figure 4.2 is a summary of the regulatory failures detected in the findings while reviewing the documents related to the Tongaat mall collapse. From Figure 4.2 it is noted that the developer failed to adhere to the construction regulations. For instance, construction of the mall continued unchanged although plans were unapproved by the local authority. Various

Figure 4.2: Insights into regulatory failure experienced on the Tongaat mall project

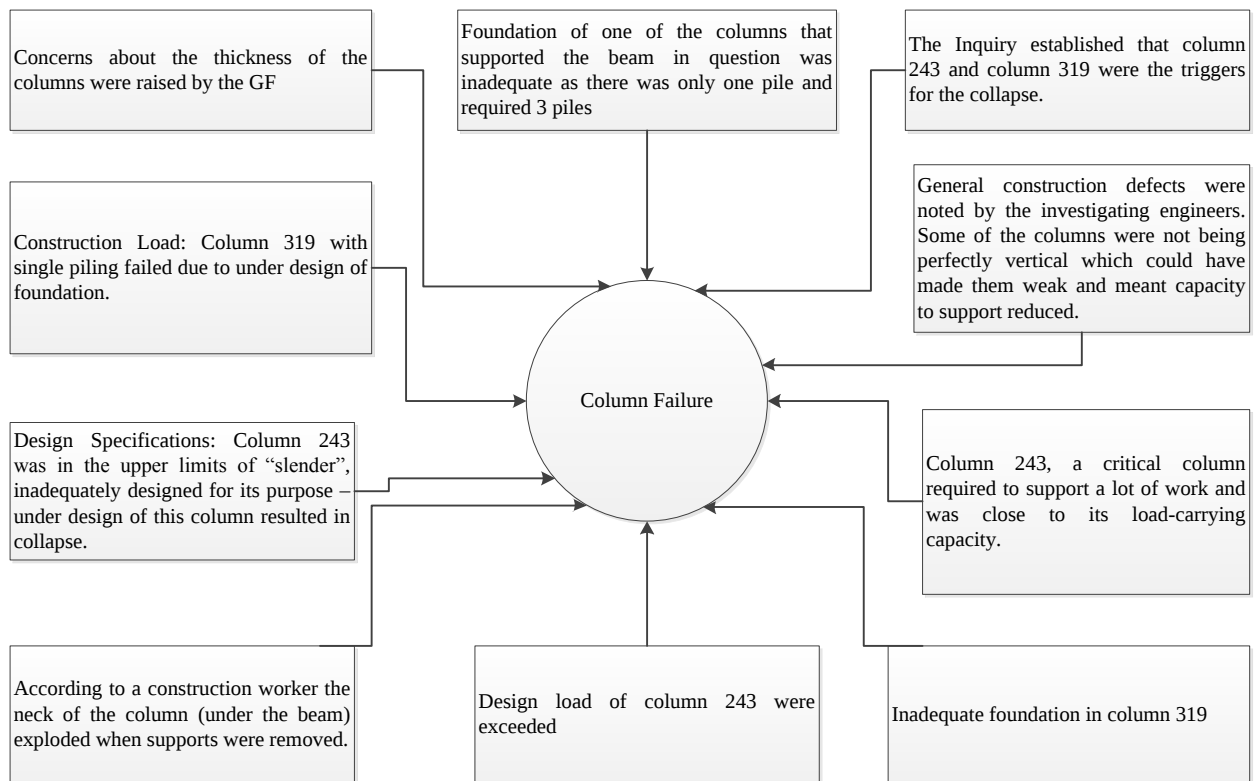
From the information above, it is apparent that two supporting columns and a beam affected the structural integrity of the collapsed slab. In Figure 4.5, the most significant findings in terms of columns failures are highlighted. Figure 4.5 shows various concerns in terms of the concrete strength and foundation design of columns. Figure 4.6 indicates the partly collapsed slab and dismembered columns. Column joints can also be seen, which indicates that columns were not poured in one continuous operation. Figure 4.7 indicates shoddy construction work in terms of column construction that was notable throughout the construction site. Figure 4.8 indicates deflection of columns that was notable throughout the site. Figure 4.9 indicates columns that were notably crooked throughout the site. These figures provide photographic evidence of the extent of the shoddy construction work interims of column construction that was experienced on site before the collapse occurred.

Figure 4.5: Insights into the lack of structural integrity that led to column failure on the project

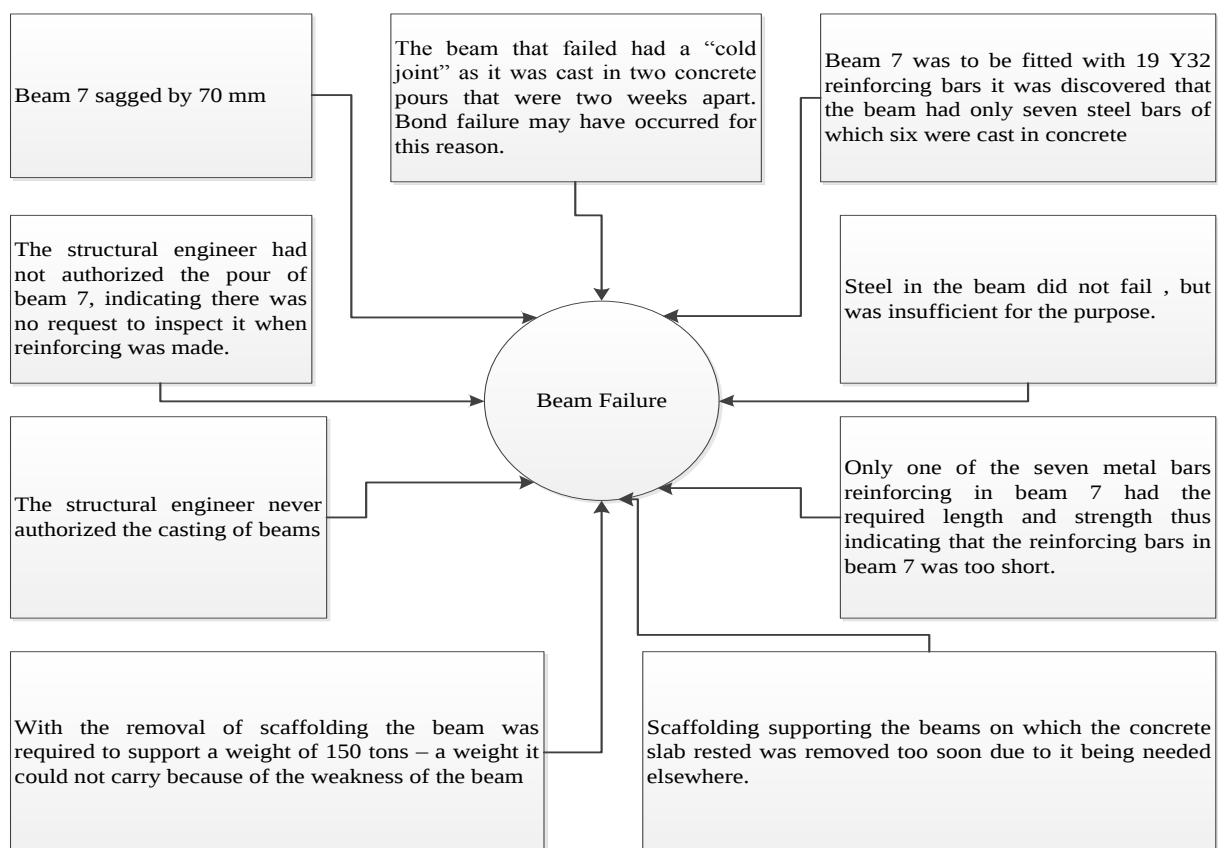
inadequate supervision or inspecting and monitoring, economic pressure, incompetent conversion, change of use of buildings and the employment of an incompetent contractor were the prominent findings that came to light. In Figure 4.10, the most significant findings in terms of beam failures are highlighted. The documents reveal that a slab known as Slab 7 sagged by 70mm. There were also various construction method deviations that were in stark contrast with what is stipulated in the construction regulations of 2003 and 2014. Figure 4.11 and Figure 4.12 point to the extent of the damage caused by the collapse. Figure 4.13 is an example of the “shoddy construction” found in the Tongaat mall project. Figure 4.14 indicates the poor concrete work that was apparent in the Tongaat mall project.

Figure 4.10: Insights into the lack of structural integrity that lead to beam failure on the Tongaat mall project
